STONE CONCRETE
CUTTING & CORING

PROJECT: GPR SCANNING - REBAR & STEEL PLATE LAYOUT

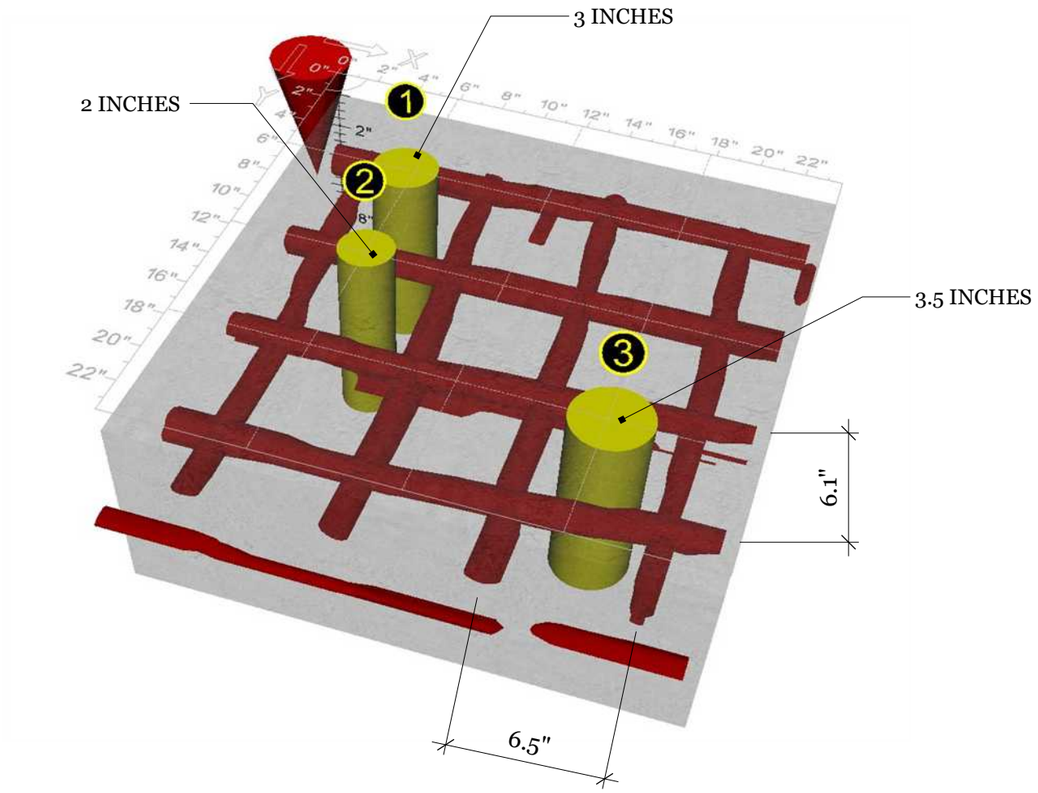
3D VIEW - CORE LOCATIONS

GPR scanning was conducted within the proposed scanning area. The survey did not identify any potential conduit within the scanned area.

Based on the GPR results, ideal coring locations were identified and marked in both the 3D and 2D views for reference.
